# 1" IMPACT WRENCH

# Model 6910 (MJ)

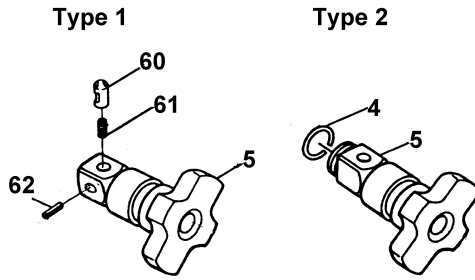
**1. Change on Anvil.**

Item No.	Description	Type 1	Type 2
4	Ring Spring 22	-----	231921-7 (Added)
5	Anvil	325414-5 (No Longer Available)	325587-4
60	Pin	325365-2 (No Longer Available)	(Discontinued)
61	Spring	231213-4 (No Longer Available)	(Discontinued)
62	Slotting Pin	256710-9 (No Longer Available)	(Discontinued)

Above parts are completely interchangeable as a set.

When replacing Type 1 Anvil, replace it with complete set of Type 2 parts.
